Re: Request for extension of Final Delivery Date
Lucero Apartments (f/k/a Oak Creek Village) Austin, Texas
Fannie Mae Forward Commitment No.: 874426
PNC Loan No: 310401235

At your request, Wiss, Janney, Elstner Associates, Inc. (WJE) has performed additional assessment of the stucco installation at the Oak Creek Village Apartments buildings, located at 2324 Wilson Street in Austin, Texas. The additional assessment included review of additional information not available to us prior to issuance of our July 22, 2016 report. This letter amends and supplements our previously provided findings and presents recommendations.

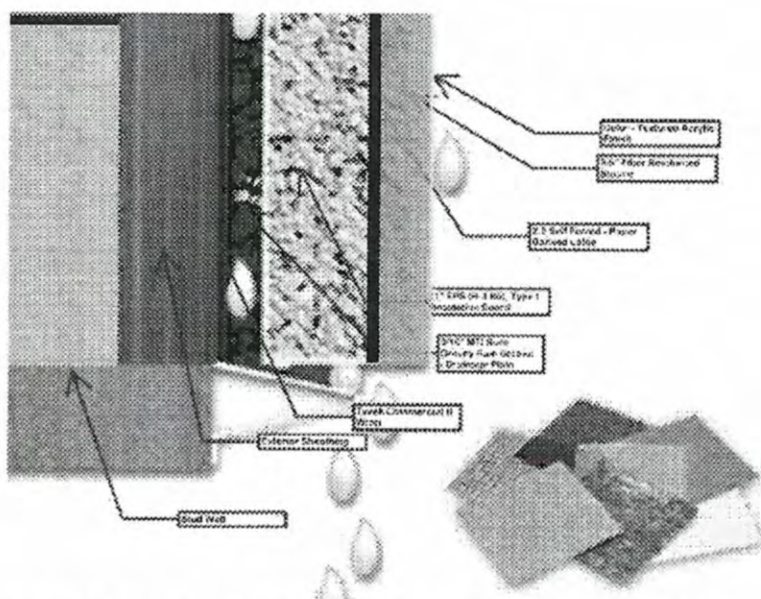
From a diagram issued via email by Weis (Figure 2) proposing a value engineering (VE) change from EIFS to stucco, we can see that the drainage of the wall system was to be provided at base terminations by a gap between the weep screed, located inboard of the drainage mat, and the metal casing bead terminating the EPS and stucco assembly.

In Weis's letter, they state that the weep screeds were installed per the relevant ICC ESR-2564; however, per Figure 2 in that document, the foundation weep screed is shown receiving the stucco, with no additional metal casing bead installed.

Figure 2. Diagram submitted by Weis for VE proposal to replace EIFS system with Parex stucco system.

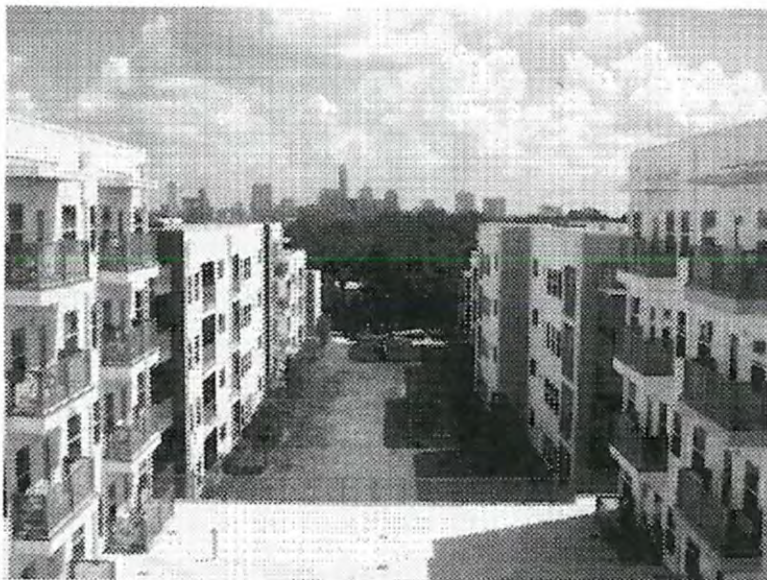
As part of our initial assessment, WJE conducted a visual survey of the exterior walls, focusing on the installed stucco system (Figure 3). Upon subsequent receipt of additional documentation, we reevaluated

Figure 3. Courtyard overview.
